AMENDMENT NO. 1

TO ENGINEERING SPECIFICATION OF

COMMISSION TECNICA Y FINANCIERA DE LAS CERCAS HIDROELECTRICAS

DEL RIO NEGRO (CHILE), CHILE

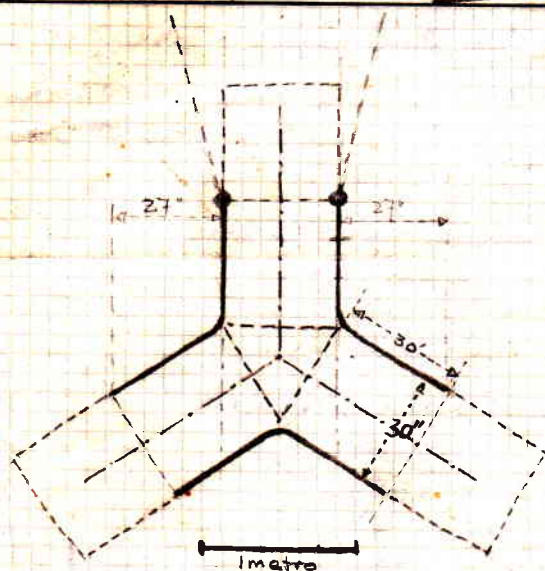
Se toma una resistencia unitaria de 3000 $\Omega/\text{in.}^3$ resmeta: $\gamma = 3000$.

$$\frac{r \times 30}{30 \times x} I = 13,800 \quad / \quad I = 700 \text{ amp.}$$

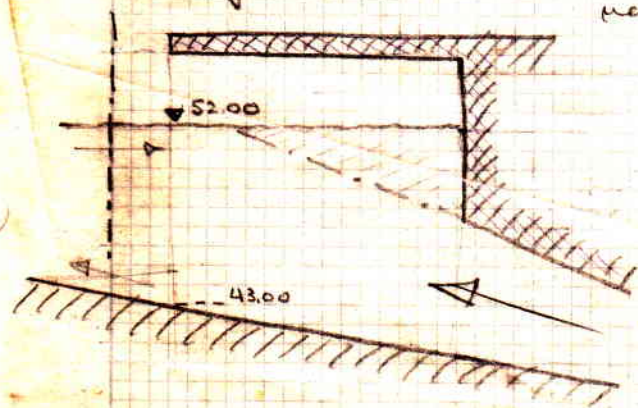
Formula de la parte inferior de las placas -

Supongamos una profundidad mínima de inmersión de 10"
para tubos se tiene:
